Manhole Inspection Summary

Manhole # S69Q__001MH

Insp Date: **5/21/08 9:36 AM**

Location Address: **1601 Danville Ave.**

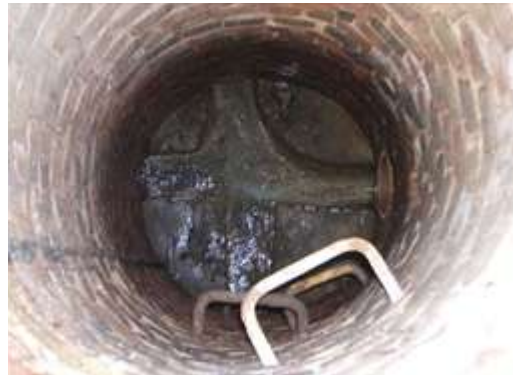
Top View

Condition: ☐ Sound ☐ Cracked ☐ Root Intrusion ☒ **Loose Brick** ☐ Deteriorated

Condition: ☐ Sound ☐ Cracked ☐ Root Intrusion ☐ Deteriorated ☐ Leaks ☒ **Debris**
